# Belvidere Theatre

129 Nevada Street  
Central City, Colorado 80427

Historic Structure Assessment and  
Preservation Plan  
SHF Grant No. 2016-HA-005  
Deliverable #5 Final HSA  
July 2016

**HISTORIC STRUCTURE ASSESSMENT  
AND  
PRESERVATION PLAN**

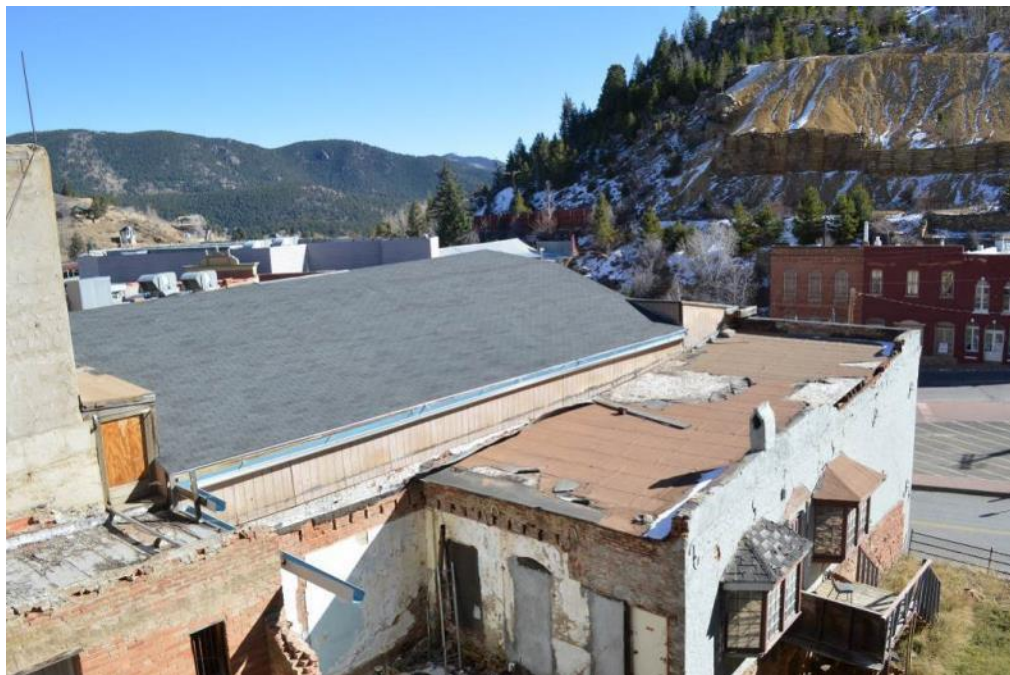
*Figure 93: Overall view of the south side of the theatre roof.*

- Replace the roof on the theatre space with historically appropriate roofing material such as corrugated metal. (Serious)
- When the roof is replaced, install sheet metal flashing where required. (Routine)

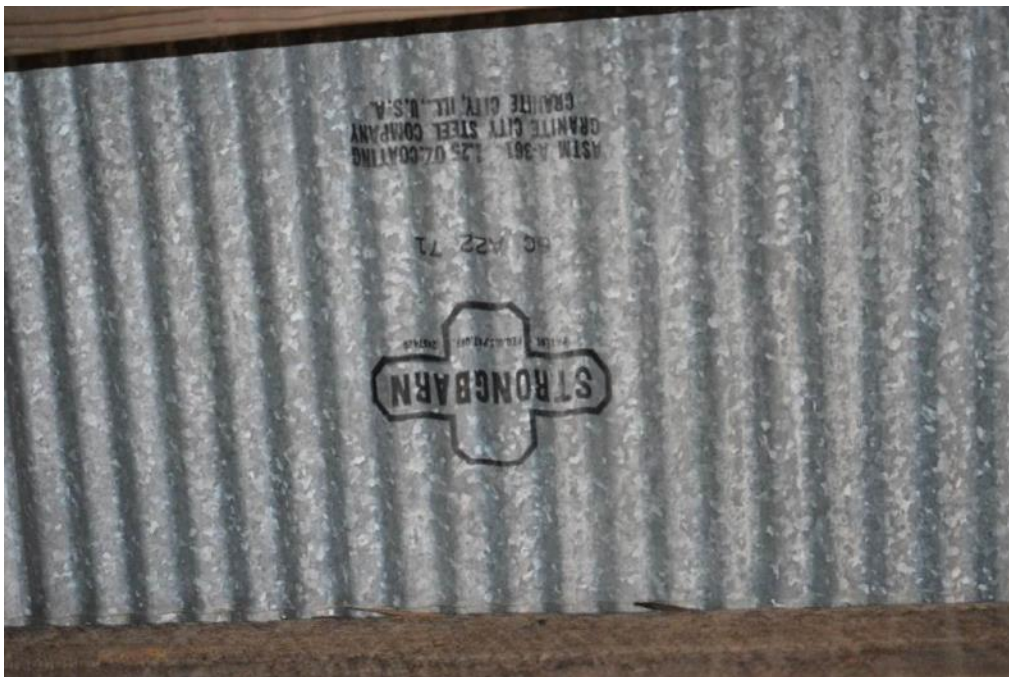
*Figure 95: Detail view of corrugated metal roofing material visible in the attic space. Note ASTM and trademark information stamped on the material.*

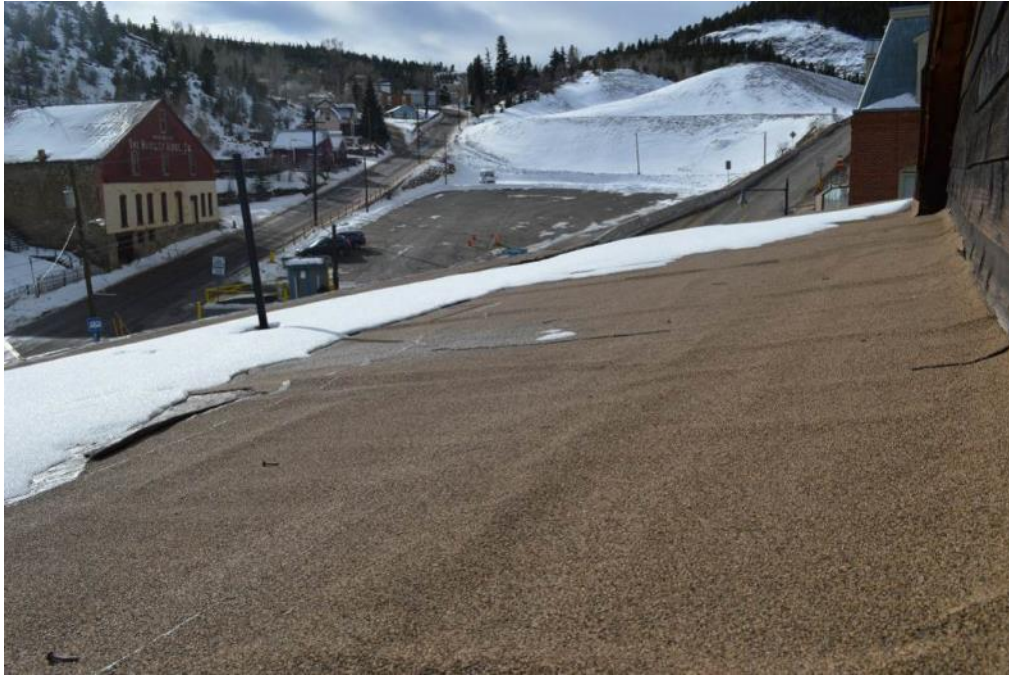
*Figure 97: Overall view of low-slope roof at the east end of the theatre.*

- Replace roof at the east section of the theatre with appropriate roofing material such as corrugated metal panels or asphalt roll roofing. If a flat roof is re-established to match the historic appearance of the building, flat roofing material such as EPDM may be used in this area. (Critical)
- Replace roof on the Shoo Fly section of the building. A membrane material such as EPDM would be an appropriate replacement material for this section of the building. (Critical)
- Replace lower flat roof located to the south of the fly space (identified as the 'cooler' on the lower level floor plan). A membrane roofing material such as EPDM would be an appropriate replacement material for this section of the building. (Critical)
- Replace roof on the fly space. A membrane material such as EPDM would be an appropriate replacement material for this section of the building. (Serious)

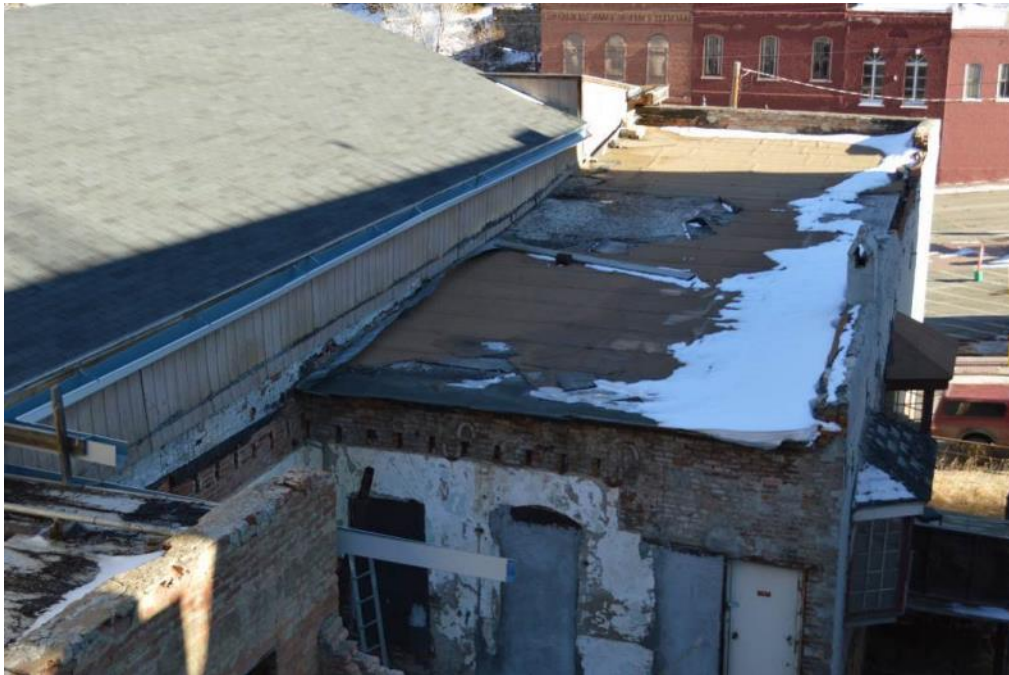
The roof on the Shoo Fly section of the building is in poor condition (*Re: Figure 99*). Sections of asphalt roll roofing are missing, leaving OSB exposed. The remaining asphalt roll roofing material is in poor condition with sections peeling up and delaminating from the sheathing. From the interior of the building, daylight is visible at the perimeter of the roof (*Re: Figure 105*). In addition, the joint between the roof and the south wall of the theatre is not sealed, which allows water into the building. This water infiltration extends to both the upper and lower level of the Shoo Fly section of the building and leads to water damage, decay, growth of mold and moss, and formation of ice during cold weather (*Re: Figure 106*).

*Figure 99: Overall view of the roof on the Shoo Fly section of the building.*

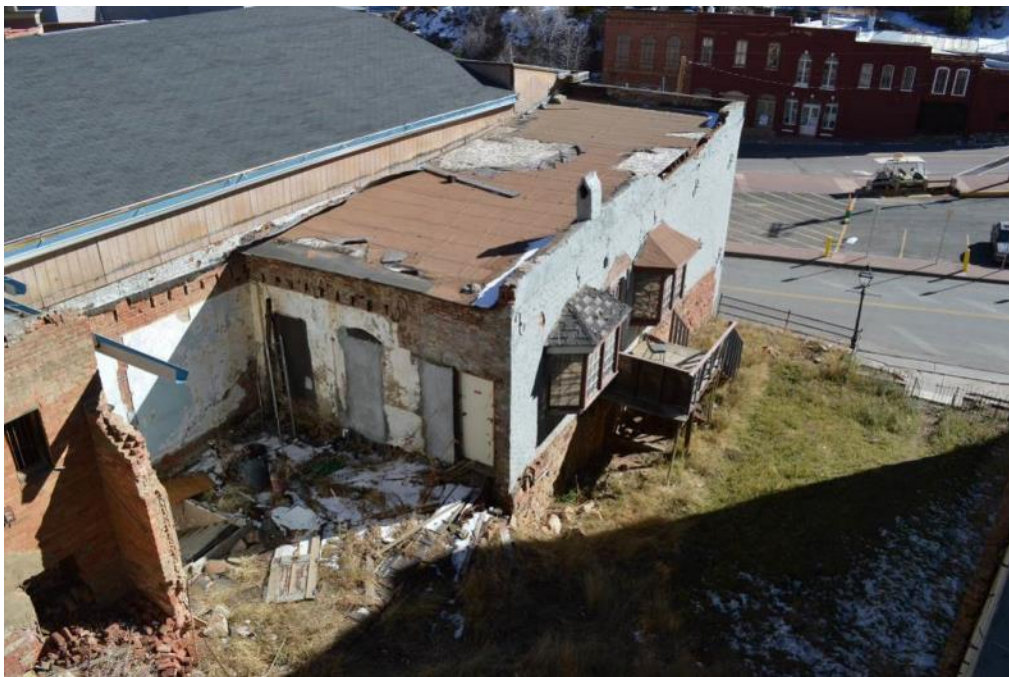
*Figure 100: Overall view of the roof on the Shoo Fly section of the building.*

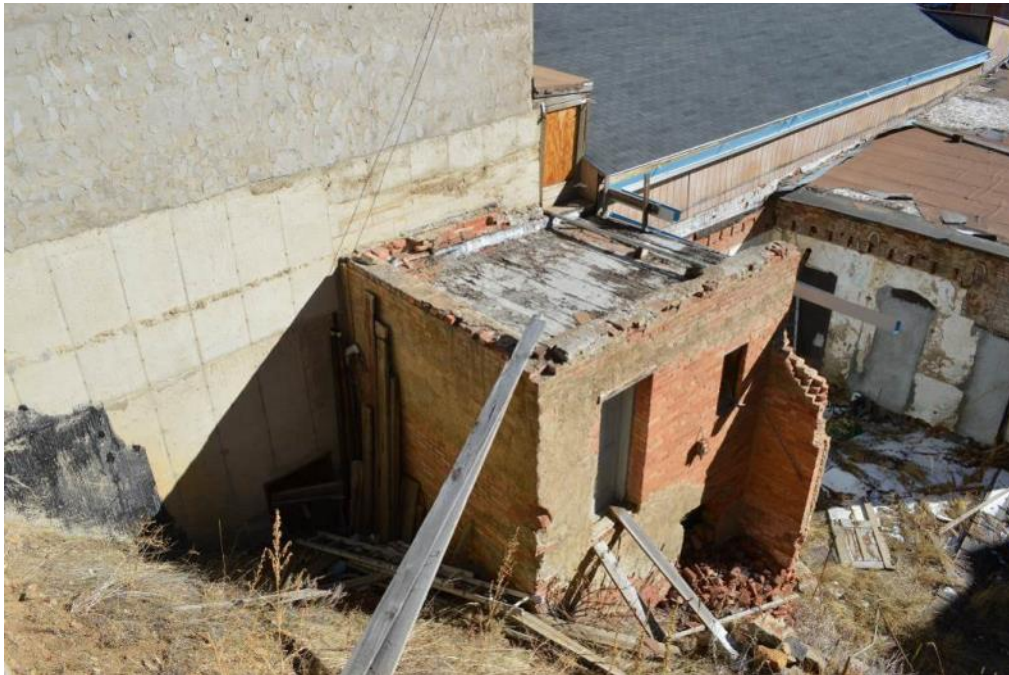
*Figure 101: Overall view of EPDM roof on the lower flat roof to the south of the fly space.*

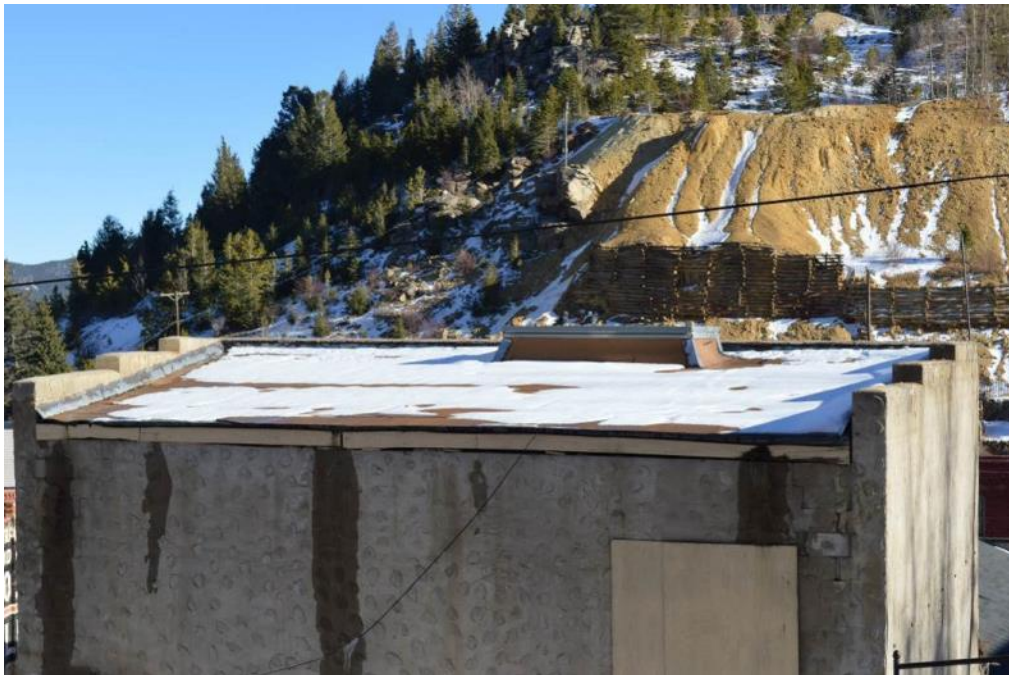
*Figure 102: Overall view of the roof on the fly space at the west end of the theatre building.*

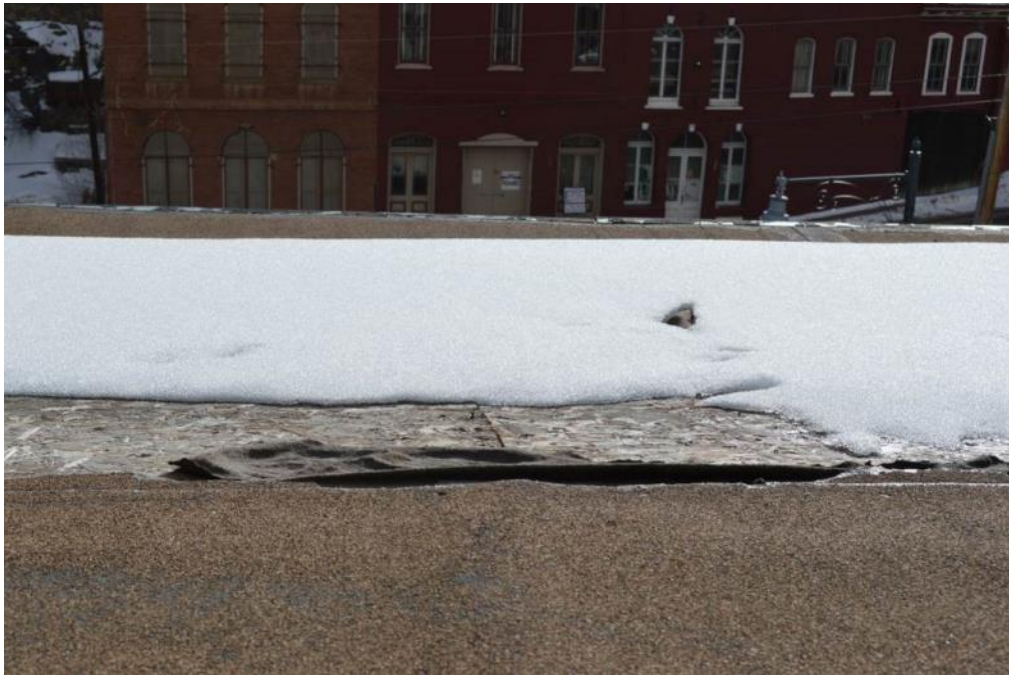
*Figure 103: Overall view of OSB sheathing along the east end of the theatre.*

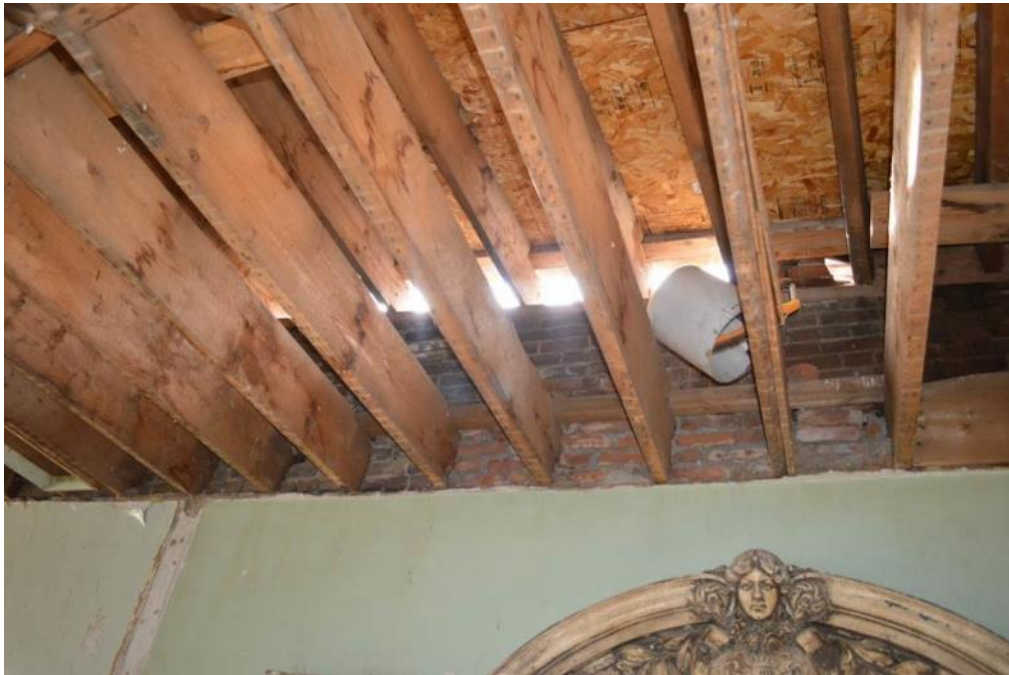
*Figure 105: View of the Shoo Fly roof from the interior of the building.*

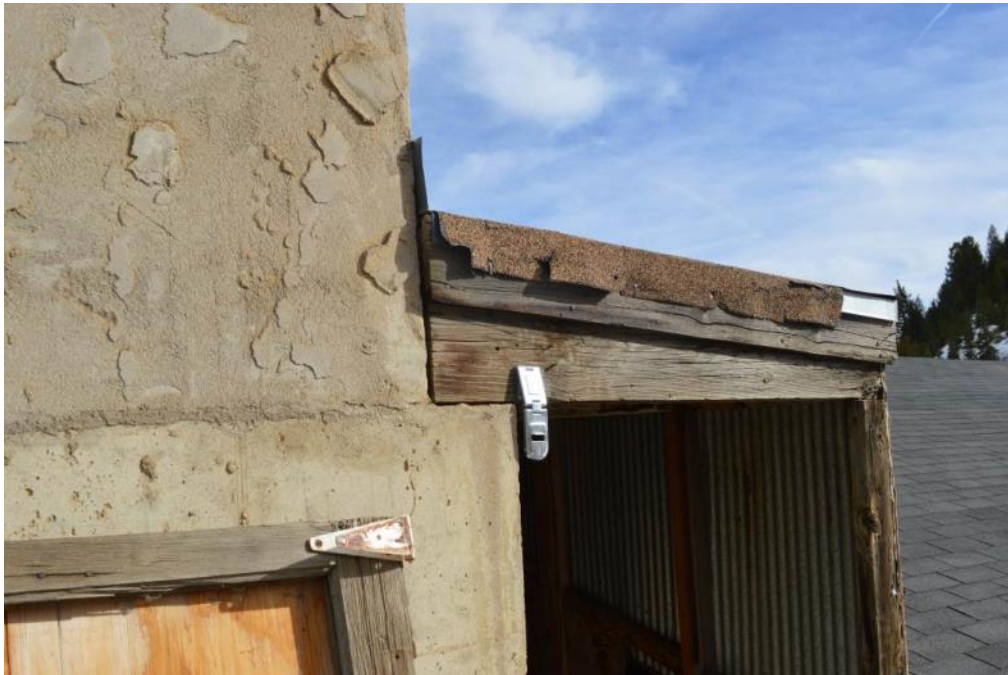
At the east end of the theatre, the pitched roof at the east end of the building projects above the main roof. At either end, the back side of the east roof is covered with sheet metal panels. The upper section of the north elevation is covered with sheet metal panels which are interrupted by truss ends which extend through the sheet metal panels. Along the north and south elevations, sheet metal flashing is visible along the roof edges. At the attic access opening at the west end of the theatre space, edge flashing is visible below asphalt roll roofing material (*Re: Figure 107*).

The sheet metal flashing visible on the theatre section of the building is in fair condition. The flashing has sections of deformed material.

*Figure 107: Detail view of edge flashing at attic access opening.*

- Replace flashing when roofs are replaced. (Critical)
- If roof replacement will not be imminent, temporarily protect open joints such as the joint between the Shoo Fly roof and the south wall of the theatre section of the building. (Critical)

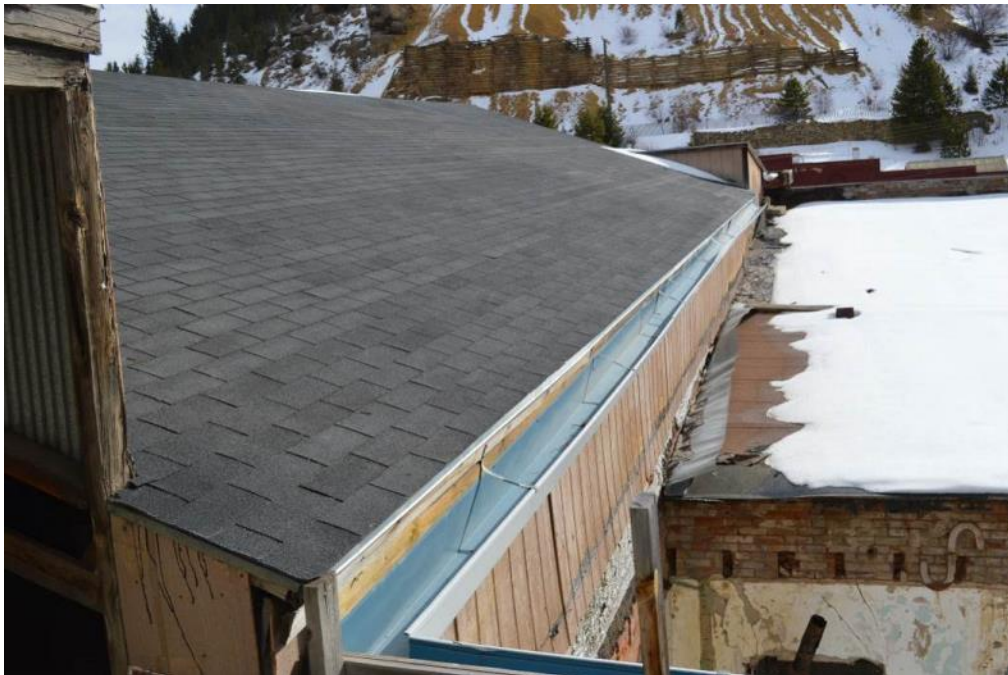
Along the north and south edges of the theatre roof there are K-style sheet metal gutters (*Re: Figure 108*). These gutters are approximately 6 inches wide and 6 inches deep. At the northeast corner of the theatre there is a downspout which is piped below grade. The pipe daylights at the curb adjacent to the parking spaces to the northeast of the building.

The gutters along the north and south edges of the theatre roof are in poor condition. The gutters are bent and deformed (*Re: Figure 109*). The downspout at the northeast corner of the building is in poor condition. The paint and brick behind the downspout are deteriorated, indicating that the

*Figure 108: Overall view of gutter along the south edge of the theatre roof.*

- Replace gutters along the north and south elevations of the theatre. (Critical)
- Replace downspout at the northeast corner of the building and direct discharge into underground drainage system. (Critical)
- Replace gutter and downspout along the edge of the lower roof to the south of the fly space. (Critical)
- Install gutter and downspout along the west elevation of the fly space. (Critical)

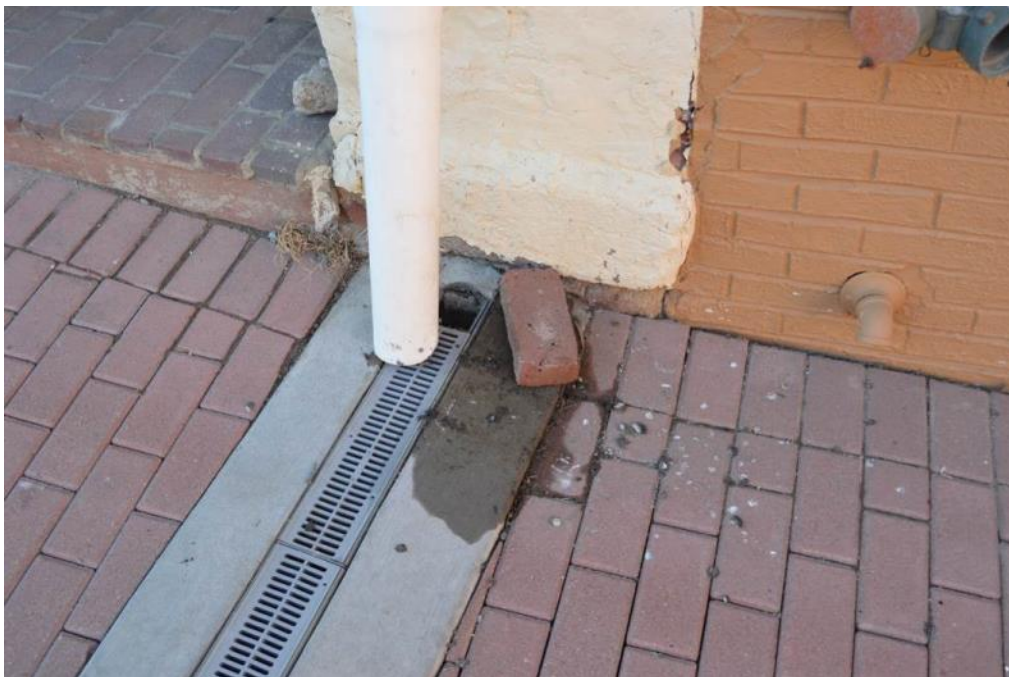
downspout is leaking. In addition, water is ponding next to the downspout discharge where the downspout is piped underground (Re: *Figure 110*).

*Figure 110: Downspout discharge at the northeast corner of the building.*

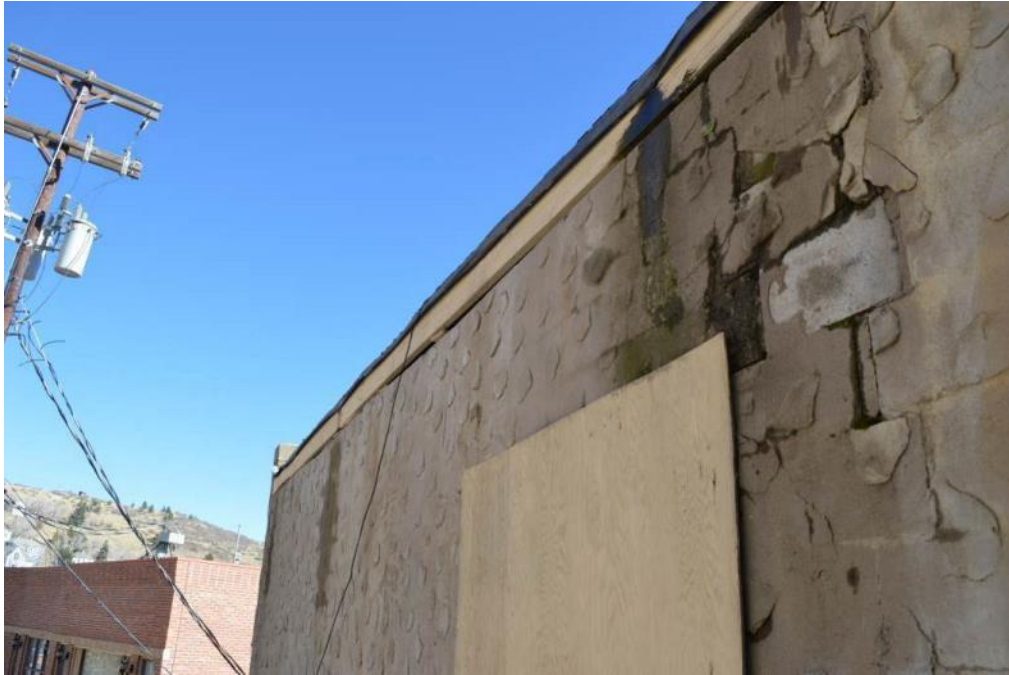
The roof of the fly space does not have a gutter to prevent drainage down the face of the west elevation of the building. As a result there is water staining at the northwest corner of the building and in the middle of the west elevation, where the roof drainage collects and runs down the face of the masonry (Re: *Figure 111 and Figure 112*).

*Figure 111: West elevation of fly space. Note water running down the face of the wall due to a lack of gutter and downspout.*

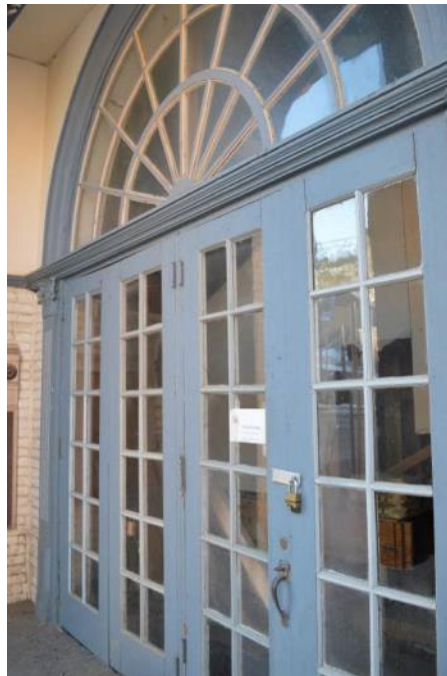
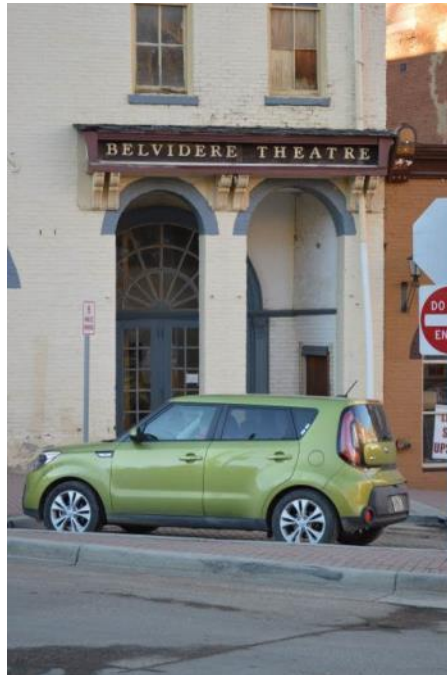
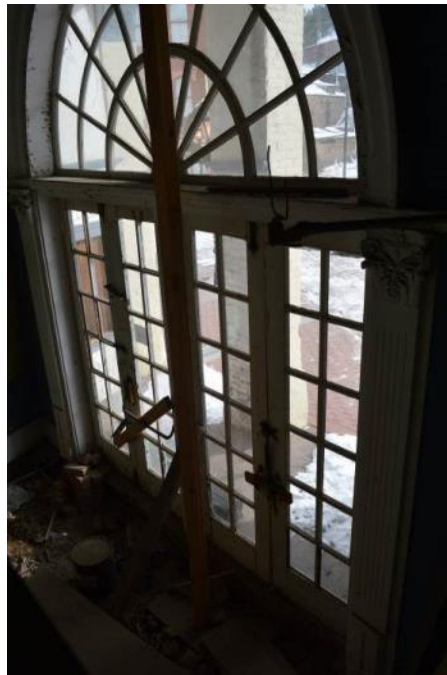
At the north end of the east elevation there are two sets of doors located within the entry area (*Re: Figure 113, Figure 114, and Figure 115*). These doors are painted stile and rail wood doors. Each door has twelve lites in a two by six configuration. Hardware for each door leaf includes three ball tipped hinges and a handle. The north set of doors also has a deadbolt and a hasp, hook, and padlock. Above the doors is a large arched transom window. In historic photos, double doors are visible in each of the arched openings at this entrance. These doors were in-plane with the exterior masonry wall of the building, as opposed to the recessed entry condition that currently exists (*Re: Figure 3*).

The doors at the north end of the theatre section of the building are in fair condition. This entrance has been reconfigured since the original construction of the building and is no longer a usable entrance. The doors are not the historic doors for this entrance, as the original entrance at the north end of the east elevation included two sets of double doors in-plane with the exterior masonry wall.

*Figure 113: Overall exterior view of the doors at the north end of the building.*

*Figure 114: Overall view of the exterior doors and arched entryway at the north end of the building.*

*Figure 115: Overall interior view of doors at the north end of the east elevation.*

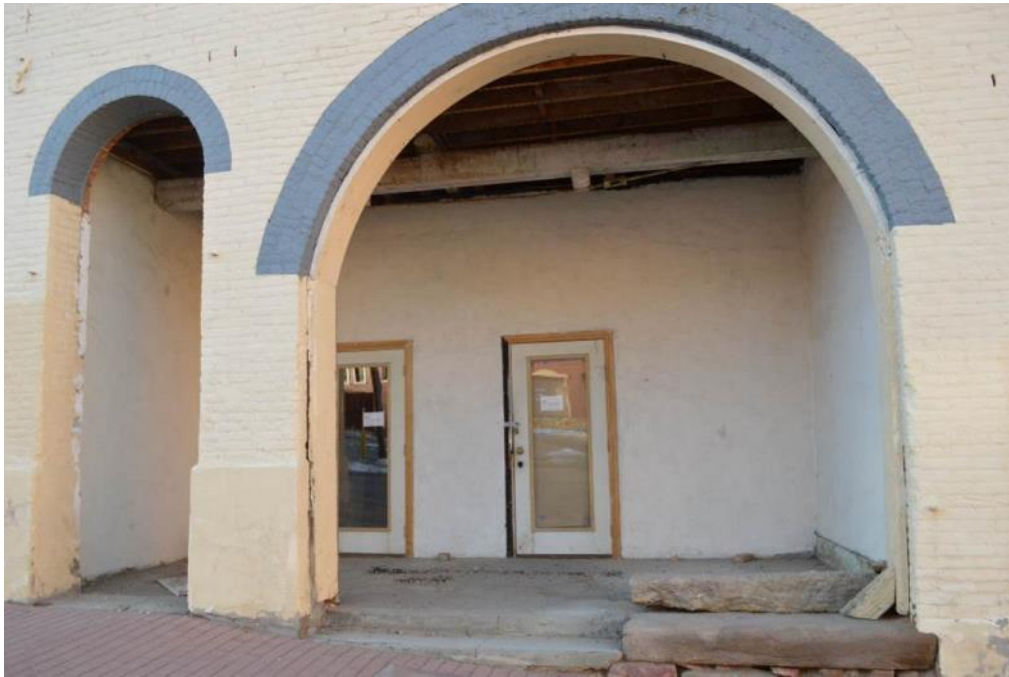
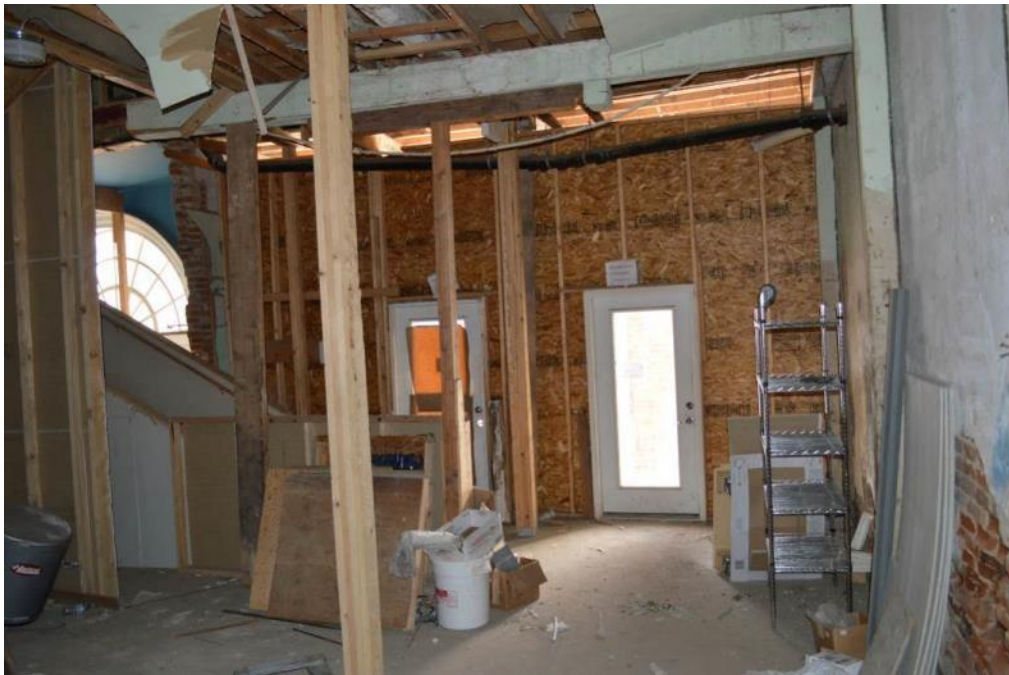
In the middle of the east elevation of the theatre section of the building there are two individual exterior doors within the recessed entry area (*Re: Figure 116 and Figure 117*). These doors are modern stile and rail doors, each with a single full glazed panel. The doors are hung in modern frames.

The two doors in the middle of the east elevation of the theatre building are in fair condition. These doors are not historically appropriate. At each door opening a section of trim is missing at the south jamb. The door components are separating. At the upper corner of the north-most door the door has cracks and chips in the material.

*Figure 116: Overall view of doors in the middle of the east elevation of the theatre section of the building.*

*Figure 117: Overall interior view of doors in the middle of the east elevation of the theatre section of the building.*

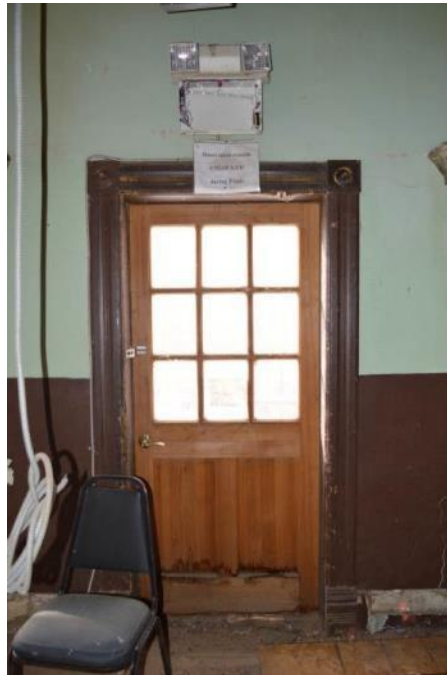
The door on the south elevation of the Shoo Fly is in fair condition. Water staining is visible on the interior of the lowest rail (*Re: Figure 126*).

*Figure 126: Interior view of the door in the south elevation of the Shoo Fly section of the building.*

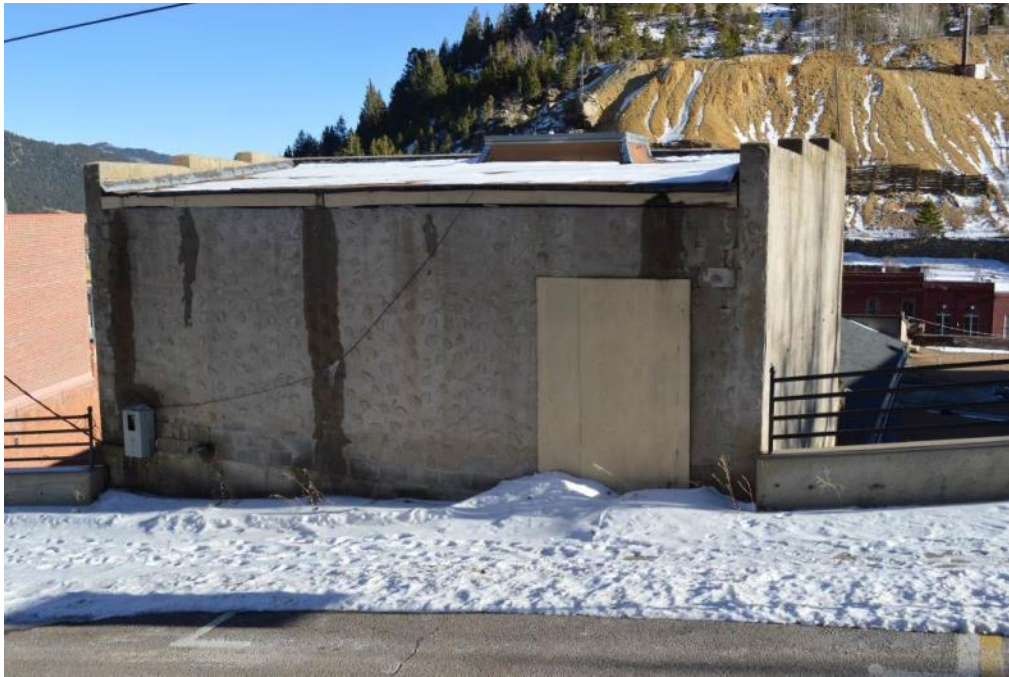
*Figure 132: West elevation of the fly space. Note boarded up door opening to the right in the photo.*

- Protect surrounding original materials when doing any repainting or sealant work. (Routine)
- Depending on the established use for the building, re-establish door openings which have been boarded up such as the door opening on the west elevation of the fly space. (Minor)

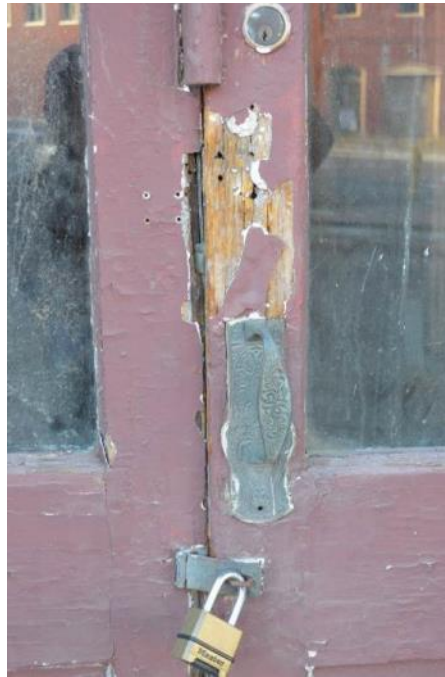
The east doors into the Shoo Fly section of the building are in fair condition (*Re: Figure 134*). Paint failure and wood weathering are typical at both sets of doors. The glazing putty is failing and is missing in some sections. A section of the center astragal at the south set of doors is missing. The north set of doors has one broken pane of glass.

*Figure 134: Detail view of exterior condition of the doors on the east elevation of the Shoo Fly section of the building.*

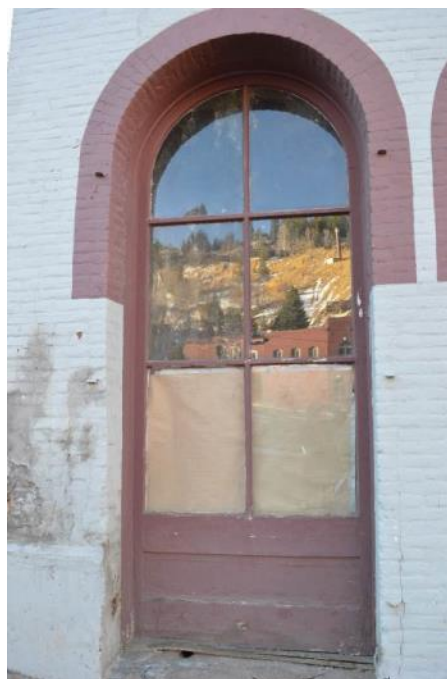
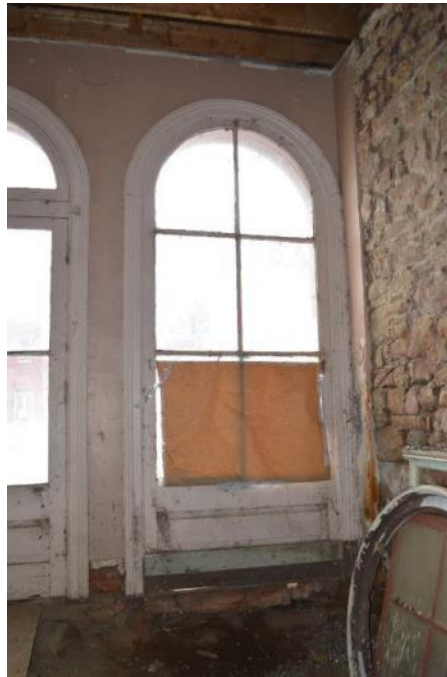
At the south end of the east elevation there is one exterior window in the lower level of the Shoo Fly section of the building (*Re: Figure 135 and Figure 136*). This window is in a round arch opening and is similar to the doors located in the round arched openings to the north. The window has six panes in a two by three configuration. Below the glazing is painted wood paneling. Based on historic photographs, this window may be original.

*Figure 135: Exterior view of the window at the south end of the east elevation of the Shoo Fly section of the building.*

*Figure 136: Interior view of the window at the south end of the east elevation of the Shoo Fly.*

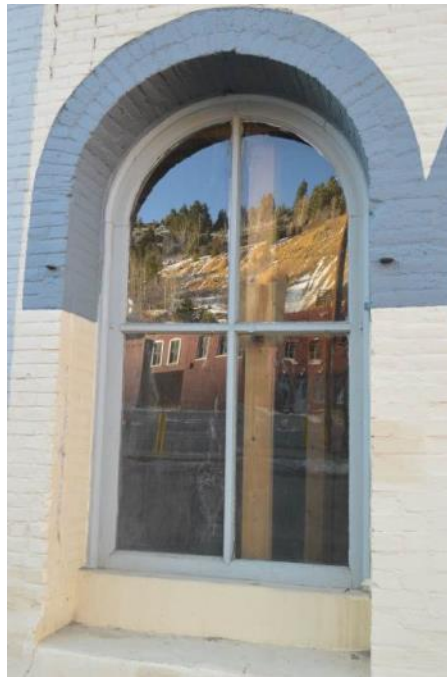
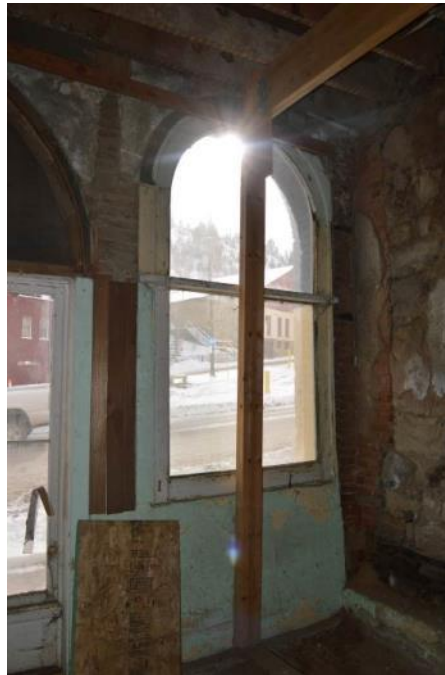
At the south end of the east elevation of the theatre section of the building there is one exterior window in the lower level (*Re: Figure 137 and Figure 138*). The window is in a round arched opening and includes four panes of glass in a two by two configuration. Based on historic photographs, this window may be original.

*Figure 137: Exterior view of east window at the south end of the theatre section of the building.*

*Figure 138: Interior view of east window at the south end of the theatre section of the building.*

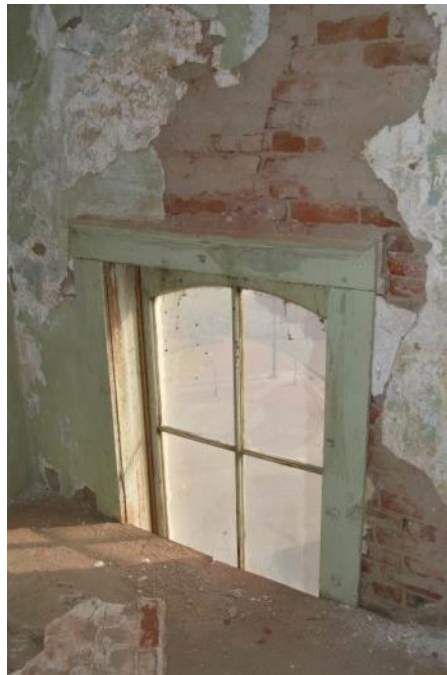
There are seven windows at the upper level of the theatre section of the building on the east elevation. These windows are likely the original windows based on historic photographs. Historic photos show that there were originally eight windows along the upper level of the theatre section of the building. One window opening was infilled at an unknown date. Each of these windows is a double hung painted wood window in a round arched opening (*Re: Figure 139*). Each of these windows measures 2 feet 9 inches by 8 feet 8 inches. On the interior, the mezzanine level falls in the middle of the openings (*Re: Figure 140*).

*Figure 140: Interior view of typical upper level window from the mezzanine.*

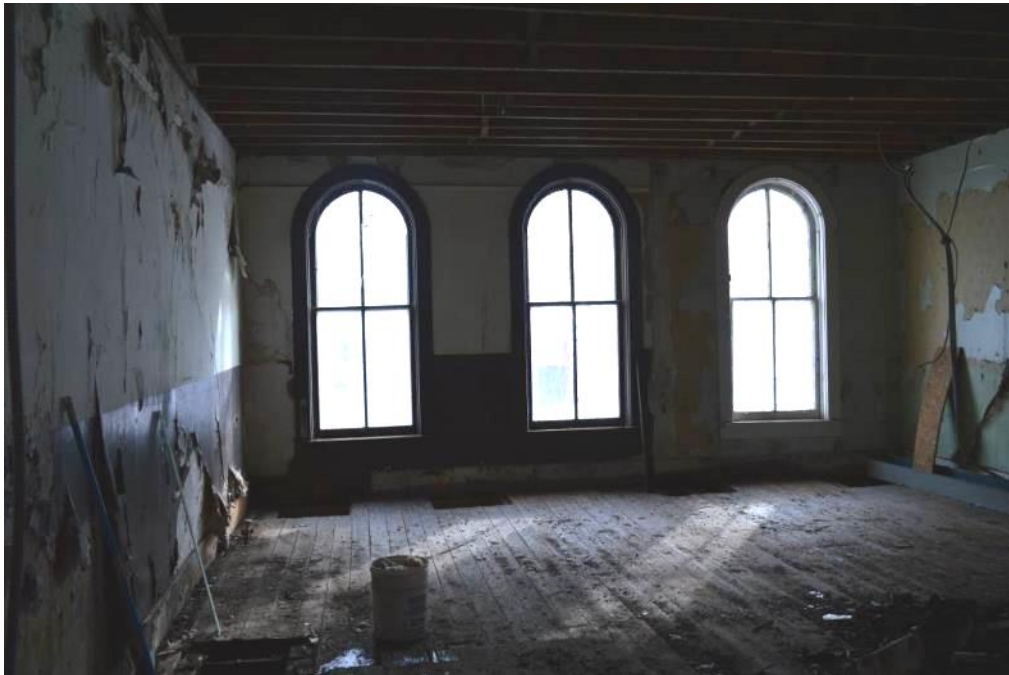
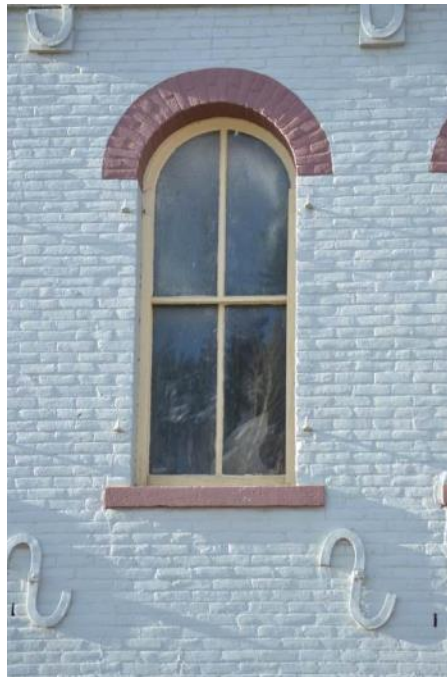
The east elevation of the Shoo Fly section of the building has three round arch window openings (*Re: Figure 141 and Figure 142*). In each opening is a wood framed double hung wood window. Each sash has two panes of glazing side by side. Based on historic photographs, these windows are believed to be original.

*Figure 141: Interior view of three east facing windows in the upper level of the Shoo Fly.*

*Figure 142: Exterior view of typical window at the upper level of the Shoo Fly section of the building.*

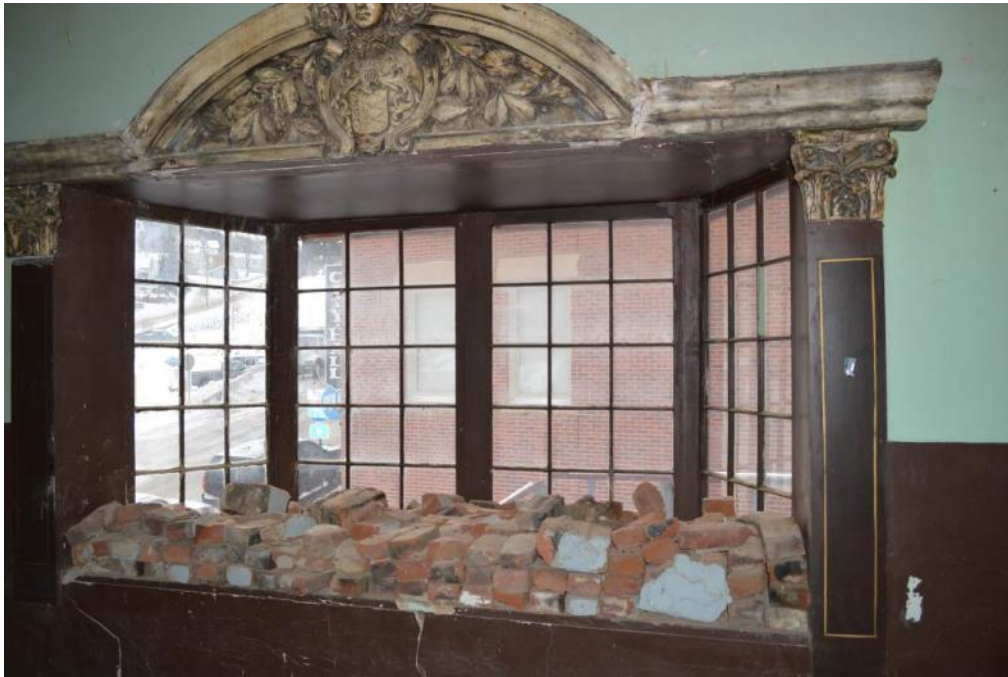
On the south elevation of the Shoo Fly there are two bay windows (*Re: Figure 143 and Figure 144*). Each opening projects approximately 3 feet south of the exterior wall. The openings for the bay windows measure approximately 8 feet 3 inches wide by 4 feet 4 inches high. The windows are fixed wood framed windows with painted wood mullions. The date of installation of these windows is unknown.

*Figure 143: Interior view of bay window on the south elevation of the Shoo Fly section of the building.*

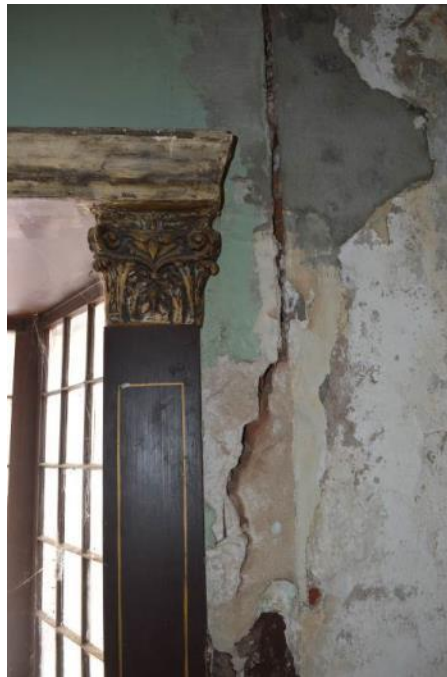
*Figure 144: Detail view of interior trim at bay window on the south elevation of the Shoo Fly section of the building.*

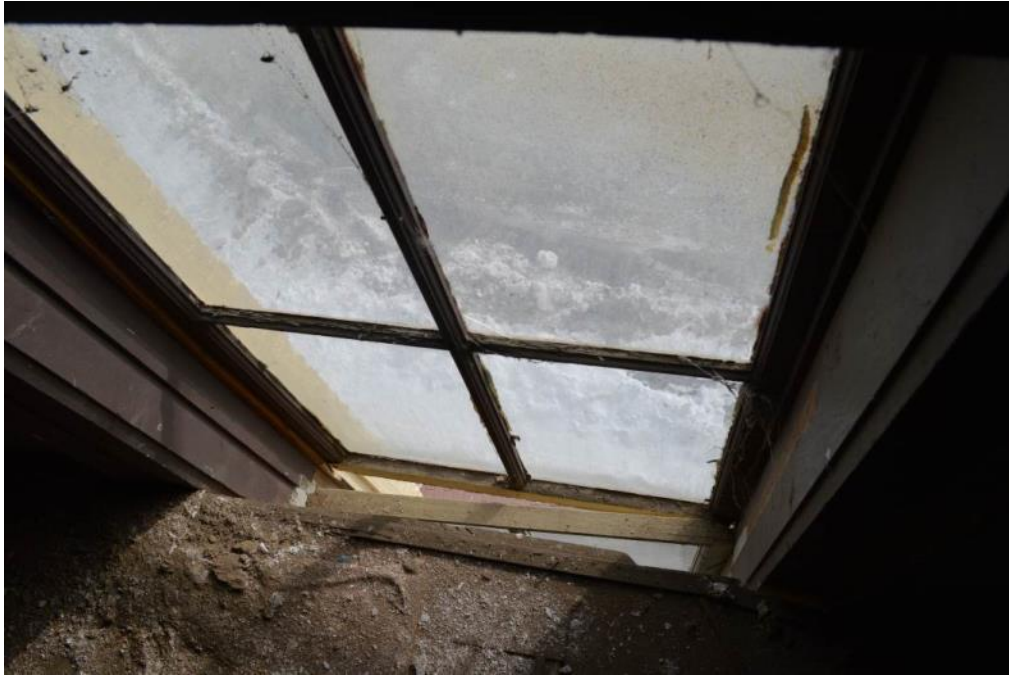
*Figure 145: Out of plane window on the east elevation of the theatre section of the building.*

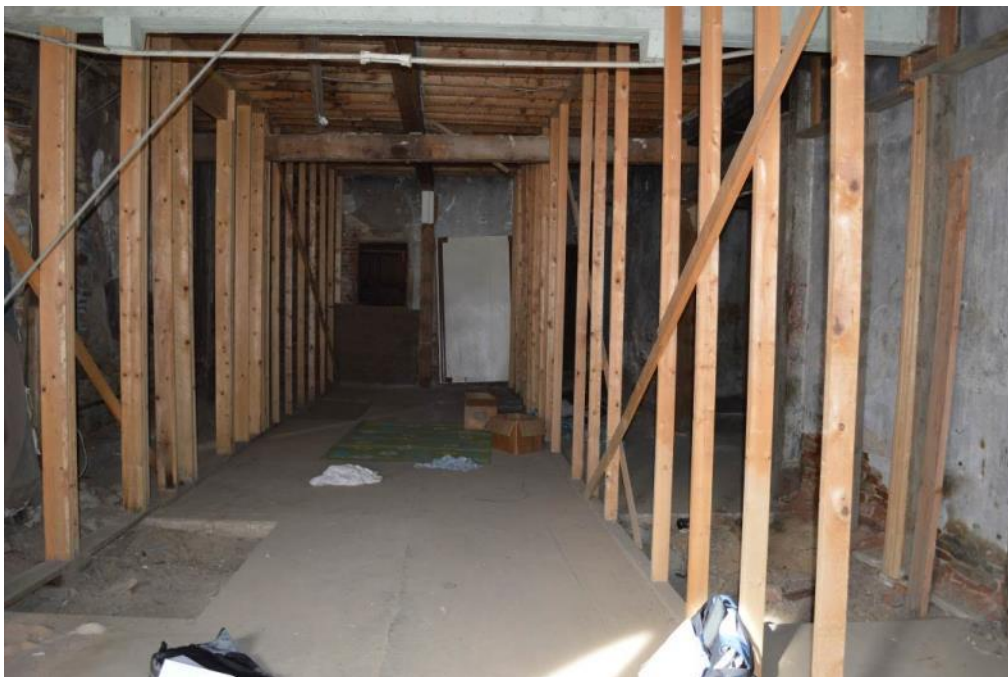
*Figure 149: Wood shoring and framing for lower level partition walls.*

- Upon determination of a use for the building and final design for interior layout, remove wood frame partitions in the lower level. Install partition walls to align with the new use for the building. (Minor)

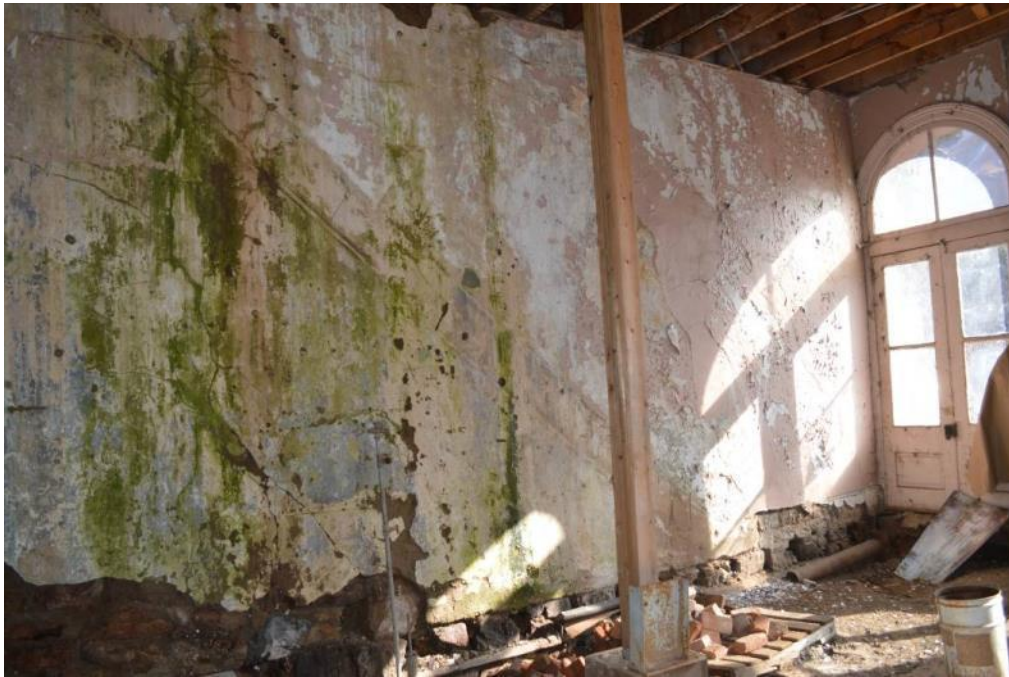
The walls in the lower level of the theatre section of the building are in poor condition. The wood frame partition walls are not original and appear to have been installed to increase support for the existing structure. The masonry bearing walls have extensive plaster delamination and are exhibiting moisture damage and deterioration. The south wall of the theatre section of the building is in very poor condition. At the east end, the wall is separating from the east masonry wall of the building. In addition, roof leaks above have led to extensive moisture infiltration which has resulted in the growth of moss and mold on the wall surface (*Re: Figure 154*).

*Figure 154: Overall view of moss and mold growth on the south wall of the theatre section of the building.*

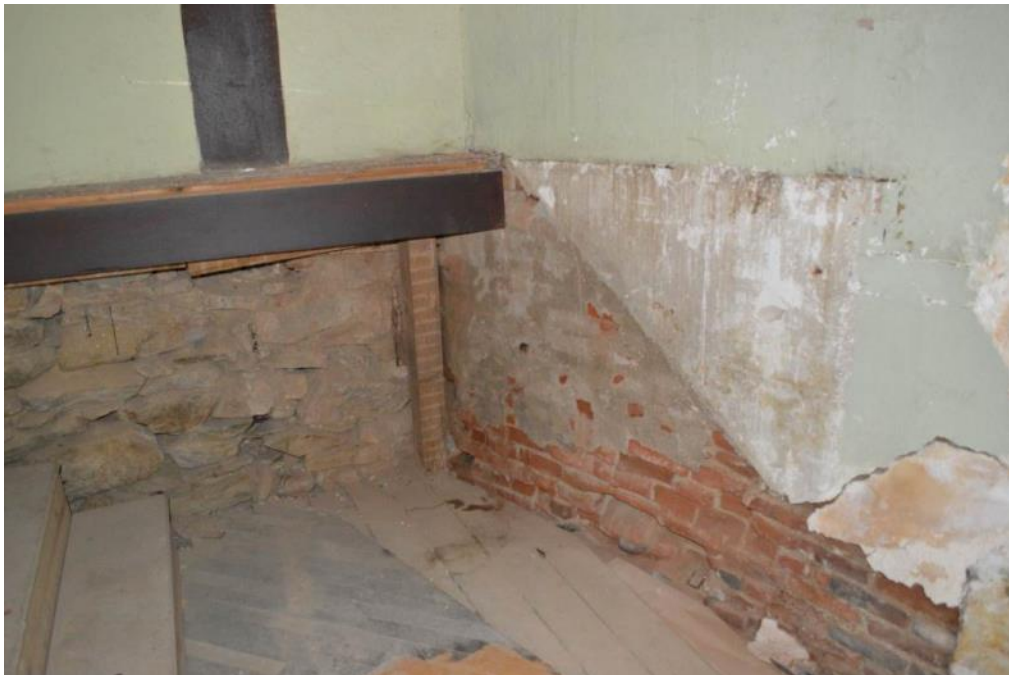
Throughout the auditorium, extensive paint and plaster damage is visible along the north and south walls. Along the north wall, there is extensive plaster delamination (*Re: Figure 155*). Where the plaster has delaminated, the brick masonry is in poor condition. Sections of brick are crumbling and powdering and sections of mortar are missing. To the west of the opening between the auditorium and the Shoo Fly, there is extensive damage to the plaster in the upper section of the wall. In the auditorium, the non-destructive moisture meter was used where extensive paint and plaster damaged was noted. In all areas, the walls read dry.

*Figure 155: Area of plaster delamination at the northwest corner of the theatre.*

- After all water intrusion repair work has been completed, rehabilitate damaged areas of plaster and paint to match existing. Follow the guidelines established in the National Park Service's Preservation Brief 21: Repairing Historic Flat Plaster – Wall and Ceilings. Damaged areas of plaster include deteriorated, delaminated, and cracked plaster surfaces. (Serious) Rehabilitation of the deteriorated plaster should include the following:
